Manhole Inspection Summary

Manhole # S51I__006MH

Location Address: **rear of 2709 eastern ave**

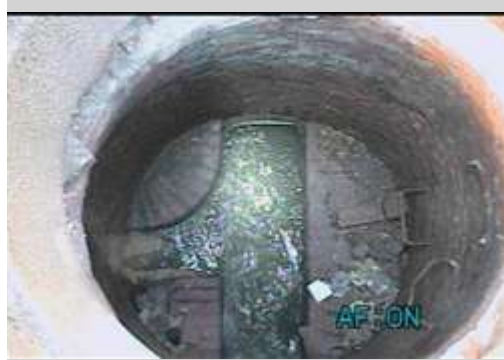
Top View

Condition: ☐ Sound ☐ Cracked ☐ Root Intrusion ☒ **Loose Brick** ☒ **Deteriorated**

Condition: ☐ Sound ☒ **Cracked** ☐ Root Intrusion ☐ Deteriorated ☐ Leaks ☒ **Debris**

Steps Count: **4** Missing: **2** ☒ **Corroded**

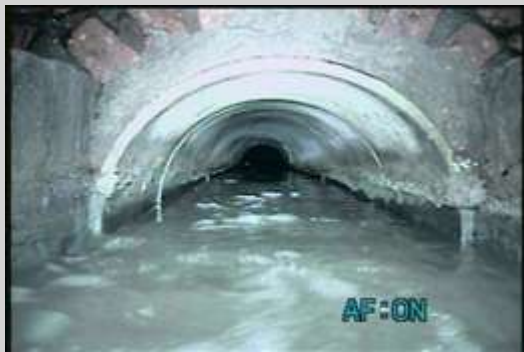
12 O'Clock Outflow

15 in. Circular Gravity Sewer
Pipe Out @ 12 O'Clock

Pipe Material: **PVC** ☐ Pipe Lined

Invert Depth: **8.64** (ft.) Flow Characteristics: **Turbulent**

Deposits: ☒ None ☐ Mud ☐ Gravel ☐ Debris ☐ Grease

Infiltration: **None** Pipe Seal Cond: **Unknown**

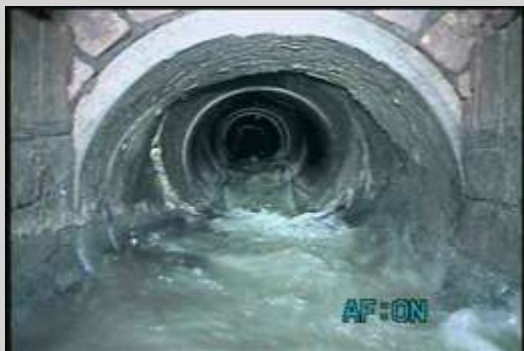
6 O'Clock Inflow

15 in. Circular Gravity Sewer
Pipe In @ 6 O'Clock

Pipe Material: **Clay** ☐ Pipe Lined

Infiltration: **None** Pipe Seal Cond: **Unknown**
